Hoosic River Restoration Plan

Amy Kimball

Jayoung Koo

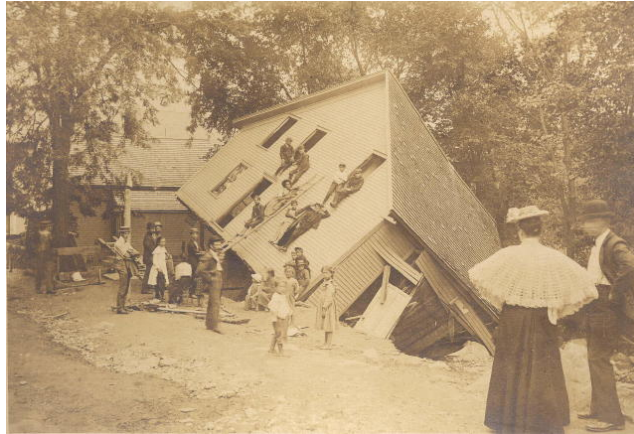
Figure 3—“Boys reclining on the face of a toppled house are making light of the devastating aftermath of the 1901 Flood. This photograph shows an East Hoosac Street house that was destroyed by the Miller Brook which runs along its back edge.” (Adams Historical Society)

Frequent flooding in the first half of the 20th Century had devastating effects on the Town of Adams. Photos from a flood in 1901 show the foundations of houses washed out from underneath them (Figure 3). The peak flow diagram shows peaks that correspond with the 1938 hurricane and other floods in the 1940s. Data is not available before 1920, but reports indicate that flooding was a frequent problem (Traister, 2004). In response to these floods, an Army Corps of Engineers flood control program in the 1950s created cement channels and other features to save the many homes and businesses on the banks of the Hoosic from frequent flooding. The channels were designed to contain both the 100- and 500-year floods of the South Branch Hoosic River within the levee. The levee system meets the FEMA (Federal Emergency Management Agency) freeboard

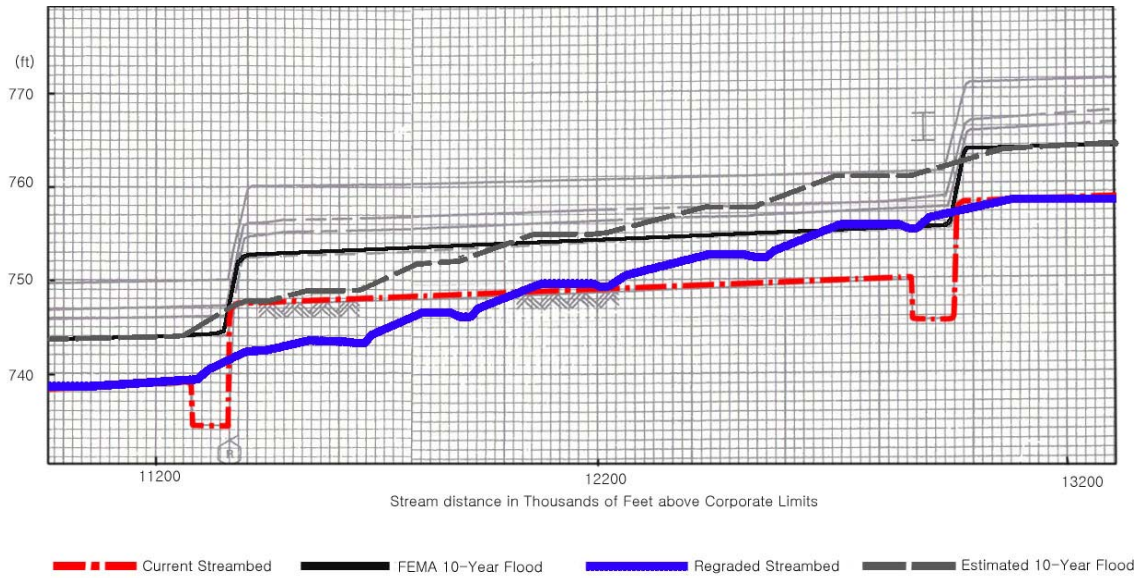
Figure 11-Regraded river bed (with FEMA Flood Profile)

The two eight-foot dams are currently impeding fish passage and discouraging human access and enjoyment of the river. A series of less dramatic drops would create a pool and riffle system that is passable by trout.

We considered a variety of designs for this slope and analyzed their flow using Manning's equation. Some had fewer, but more dramatic drops that would remain impassable to trout. We settled on this design with more drops but less severe (Table 6). This is ideal for trout passage because it features areas where the velocity is fast, followed by calmer areas in which the fish can rest. With the mean velocity of the current streamflow in the site, brook trout would not be able to swim more than 5 feet when the velocity is about 7ft per second (Figure 12). According to an article about designing culverts for fish passage, the velocity of water in the culvert (feet per second) should be based on the slowest sustained, swimming speed for the fish in the stream (UWEX). Another consideration is minimum water depth during low-flow periods. Fish may migrate during summer heat in search of cooler waters with higher oxygen levels. Brook trout should be maintained at a temperature of about 59°F and brown trout as high as 80°F (Massachusetts Department of Agricultural Resources). For these reasons, a thalweg should also be considered in stage of the project. This would remedy the low-flow conditions that are lethal to trout, and also create a run for canoes and kayaks.

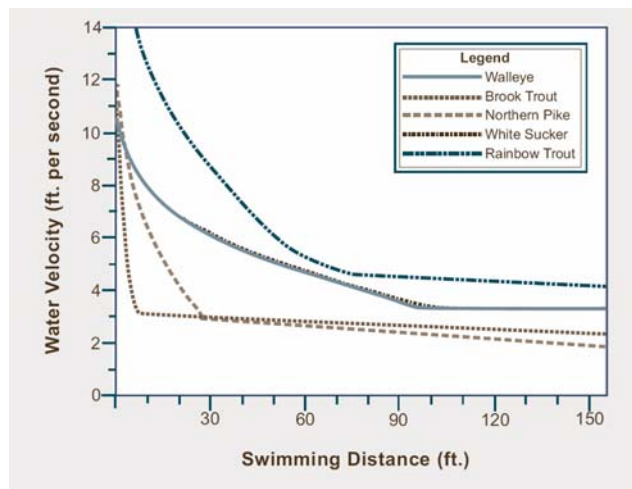
Figure 12-Limiting flow velocity for fish (Fish Friendly Culverts)
