# Hoosic River Restoration Plan

**Hoosic River Restoration Plan**  
Table of Contents

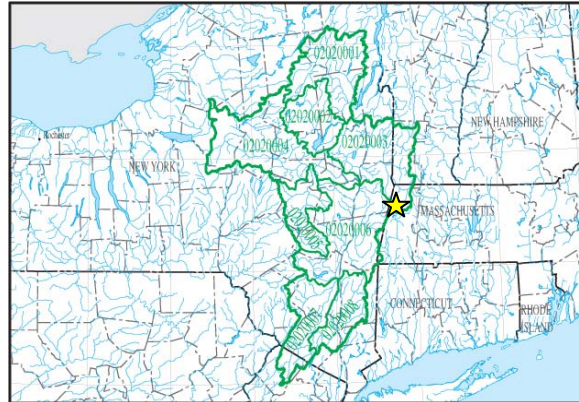
**Figure 1-**Upper Hudson Watershed (USGS)

The Hoosic River begins just south of Adams at the Chesire Reservoir and flows north for 60 miles through Adams, North Adams, then southern Vermont and New York state, where it eventually joins the Hudson river (Figures 1 and 2). The reservoir serves as the source of the South Branch of the Hoosic River. The reservoir has an area of 0.65 square miles and normal spillway elevation of 971 feet. This reservoir regulates the low-water flows and reduces the peak flood flows in Adams (FEMA, 1983).

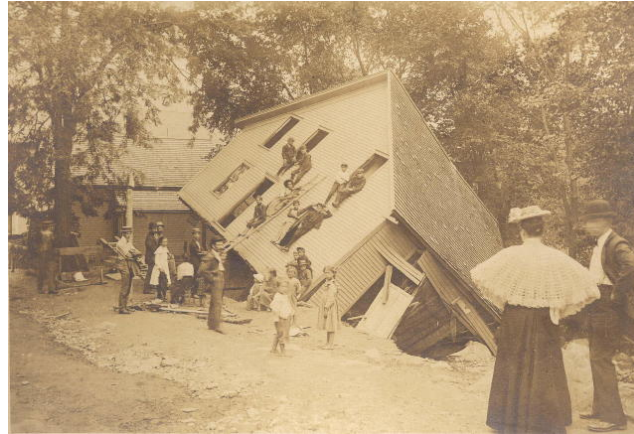
**Figure 3**—“Boys reclining on the face of a toppled house are making light of the devastating aftermath of the 1901 Flood. This photograph shows an East Hoosac Street house that was destroyed by the Miller Brook which runs along its back edge.” (Adams Historical Society)

Frequent flooding in the first half of the 20<sup>th</sup> Century had devastating effects on the Town of Adams. Photos from a flood in 1901 show the foundations of houses washed out from underneath them (Figure 3). The peak flow diagram shows peaks that correspond with the 1938 hurricane and other floods in the 1940s. Data is not available before 1920, but reports indicate that flooding was a frequent problem (Traister, 2004). In response to these floods, an Army Corps of Engineers flood control program in the 1950s created cement channels and other features to save the many homes and businesses on the banks of the Hoosic from frequent flooding. The channels were designed to contain both the 100- and 500-year floods of the South Branch Hoosic River within the levee. The levee system meets the FEMA (Federal Emergency Management Agency) freeboard

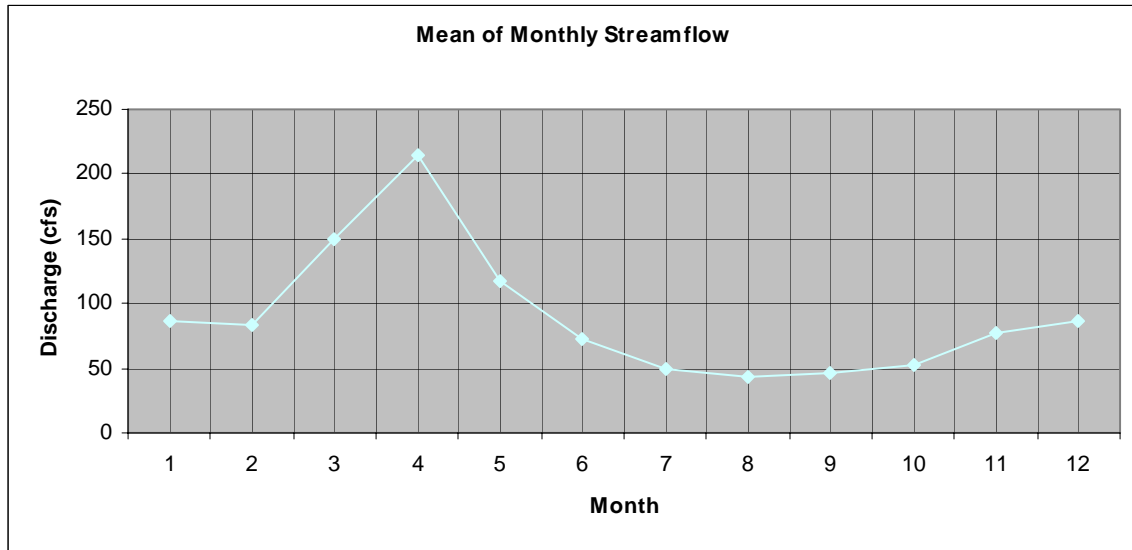
**Figure 7**-Mean Monthly Streamflow (1931~2003)

The mean of monthly streamflows was observed to determine the lowest discharge in a year that would be critical point in the movement of trout. In case of the Hoosic River, the lowest streamflows were in summer. Therefore, the measurements taken in December could be regarded as an average state for the river.

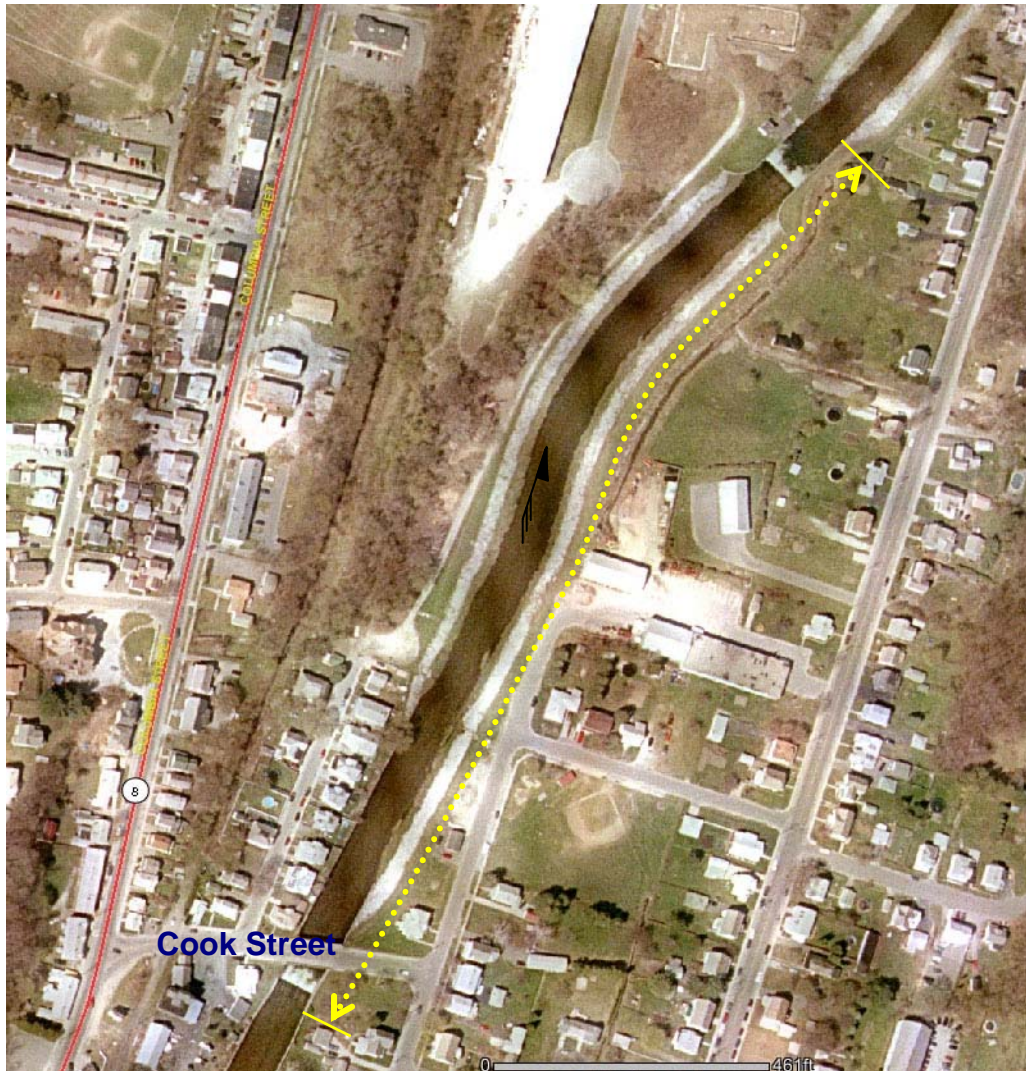
**Figure 8-Site of proposed restoration**

On the opposite side of the bridge, the water flow is much calmer (estimated at 1-2 feet per second) and the cement channel gives way to an earthen berm with a rip rap lining. The slope was measured at .6%. The area is largely free of vegetation, as the town is required to keep the berm mowed. The channel narrows and grasses have been able to grow at the base of the rip rap. We observed ducks in this spot, so it is likely that this small amount of grass is providing them with food. However, the lack of shade in the summer means increased water temperatures which can be lethal to trout. It also leaves them vulnerable to predators. A satellite image shows just how exposed this section of

river is (Figure 8). Ironically, the rectangular concrete channel gets shade at least part of the day, but this trapezoidal channel is completely open.

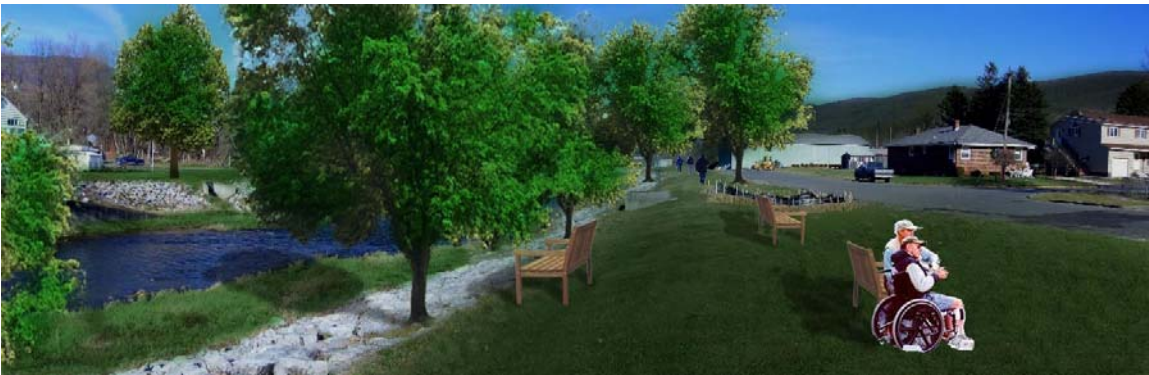
**Figure 10-**The vision for a riverside park

Trees would also make the river more inviting to people. To encourage recreation along this stretch of river, a simple solution would be to provide picnic tables or benches near the berm (Figure 10). A more extensive plan could include a handicapped-accessible ramp and platform at the edge of the river. This would allow elderly or disabled people to fish and enjoy views of the river. The demographics of Adams indicates that the population is elderly and would benefit from this form of passive recreation. For these reasons, Adams should consider making this river area into a town park. Extensive green space was encouraged in the Downtown Development Plan, and a park at this site would complement those plans. Drawing on the town’s founding members, we tentatively call this area Friends Park. The town should explore other naming opportunities that would celebrate its long and rich history. There are a number of simple steps the town can take to develop this area into a park:

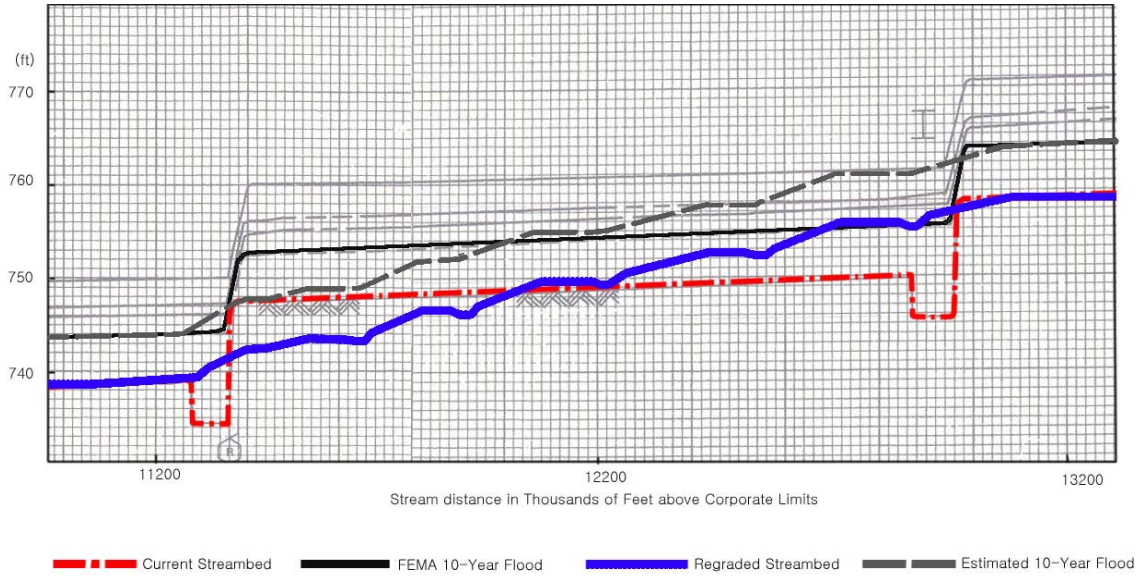
**Figure 11-Regraded river bed (with FEMA Flood Profile)**

We considered a variety of designs for this slope and analyzed their flow using Manning's equation. Some had fewer, but more dramatic drops that would remain impassable to trout. We settled on this design with more drops but less severe (Table 6). This is ideal for trout passage because it features areas where the velocity is fast, followed by calmer areas in which the fish can rest. With the mean velocity of the current streamflow in the site, brook trout would not be able to swim more than 5 feet when the velocity is about 7ft per second (Figure 12). According to an article about designing culverts for fish passage, the velocity of water in the culvert (feet per second) should be based on the slowest sustained, swimming speed for the fish in the stream (UWEX). Another consideration is minimum water depth during low-flow periods. Fish may migrate during summer heat in search of cooler waters with higher oxygen levels. Brook trout should be maintained at a temperature of about 59°F and brown trout as high as 80°F (Massachusetts Department of Agricultural Resources). For these reasons, a thalweg should also be considered in stage of the project. This would remedy the low-flow conditions that are lethal to trout, and also create a run for canoes and kayaks.

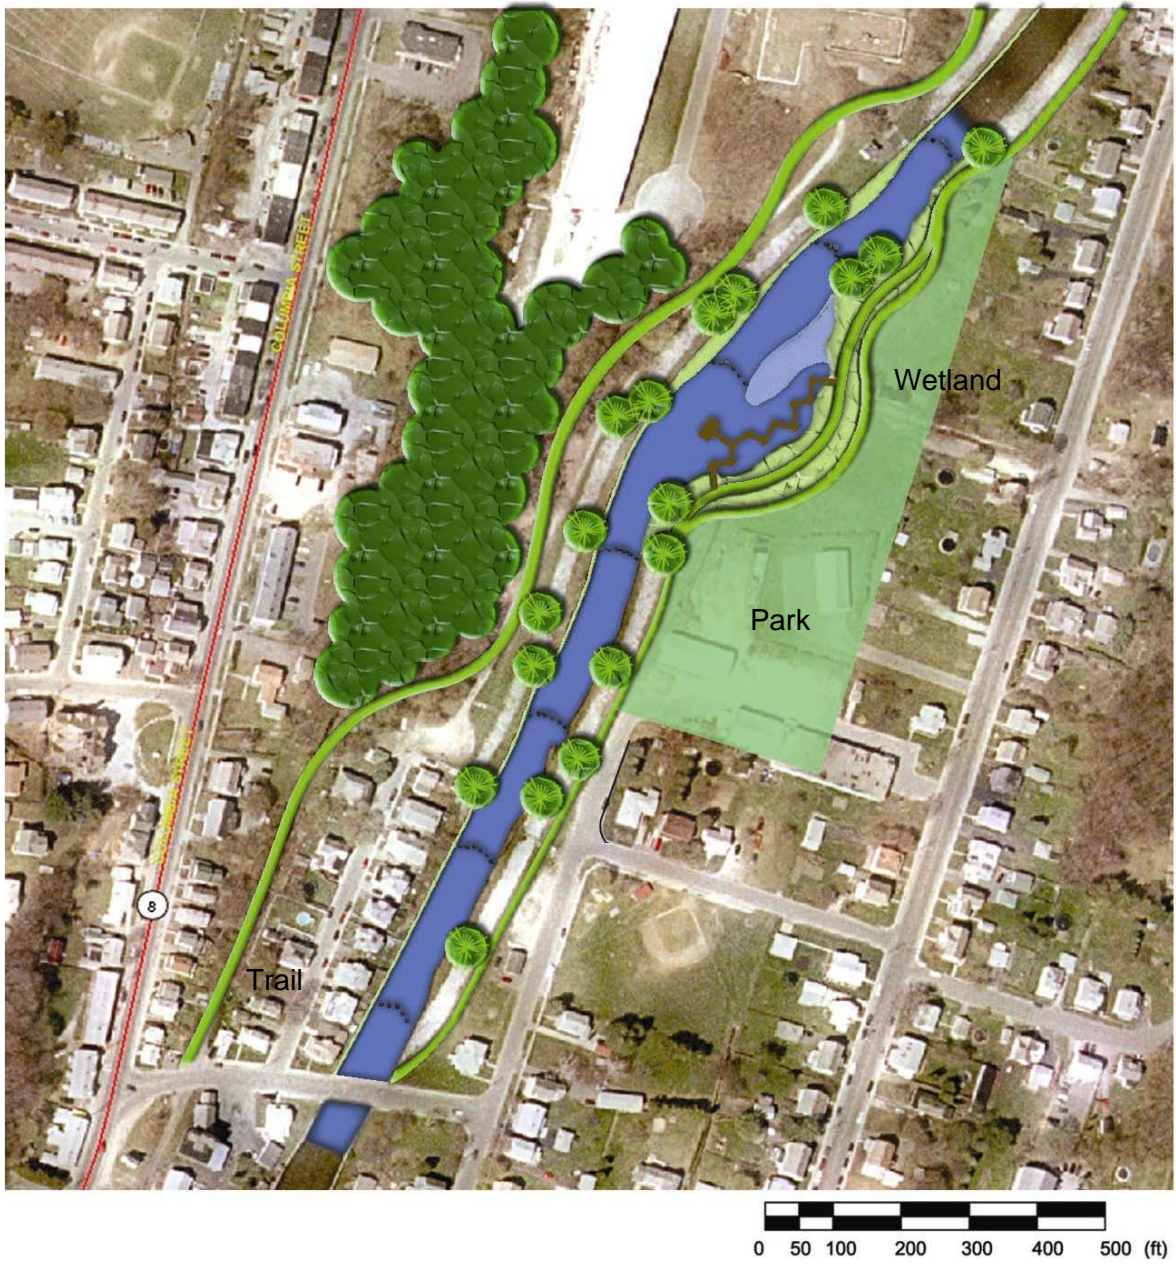
Figure 14-Master Plan

The final diagram (Figure 14) shows the most ambitious restoration of this river, including all the pieces discussed above. While it may appear daunting, it can be accomplished over many years by restoring the river a portion at a time.
